INFLUENCE OF THE HEAT TREATMENT PROCEDURE ON THE STRESS CORROSION CRACKING BEHAVIOUR OF LOW PRESSURE TURBINE BLADE MATERIAL FV566

**A thesis submitted to the Faculty of Engineering and the Built Environment,
at the University of Cape Town, in fulfilment of the degree of Master of
Science in Engineering**

June 2017

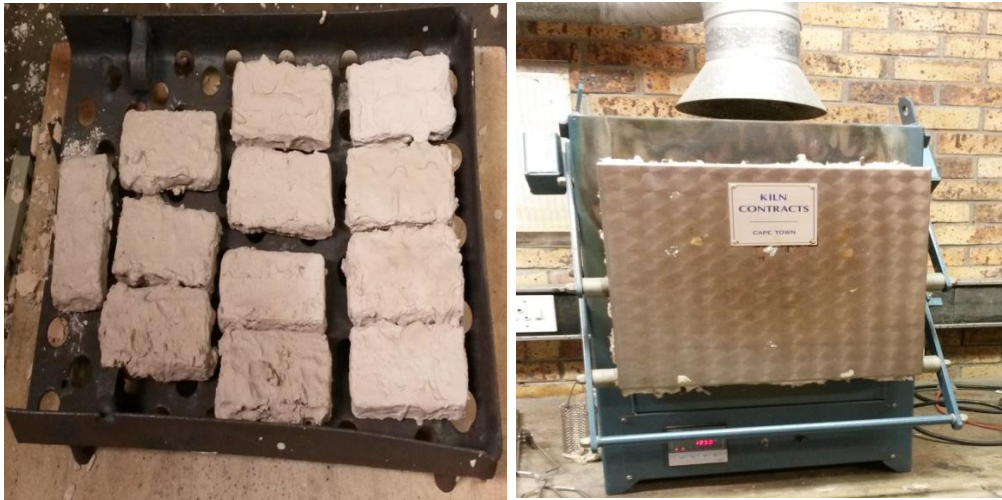
Figure 3-1: Coating of samples with Foseco Isomol and box furnace with additional thermocouples

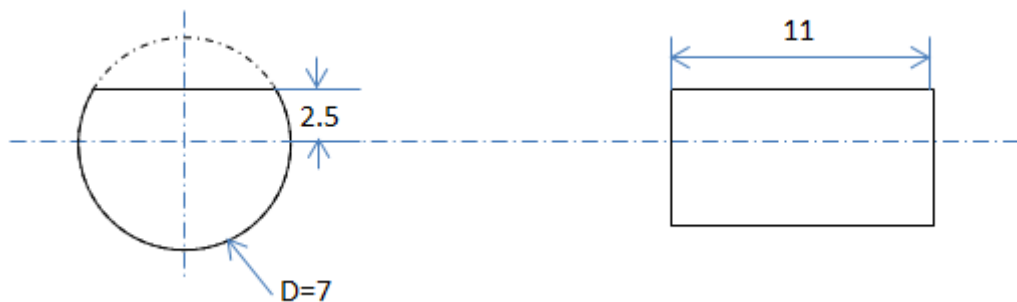
Figure 3-13: Loading Tup for WOL specimen

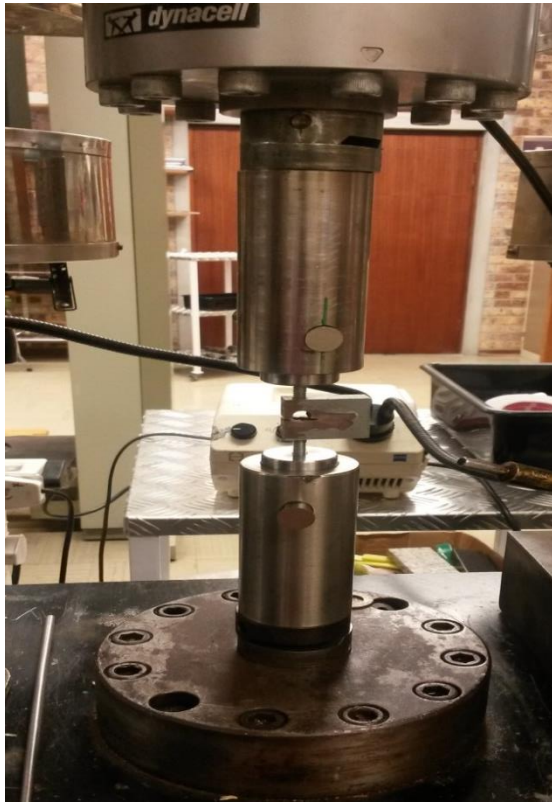
Figure 3-14: Precracking of the WOL specimen

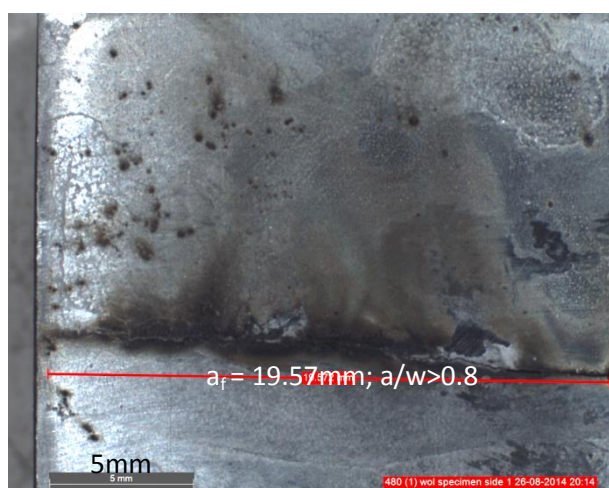
Figure C-1: 480(1) temper WOL with crack growth extending beyond $a/w=0.8$. K1SCC could not be determined as compliance equations were not satisfied
